UNDERWATER BRIDGE INSPECTION REPORT

STRUCTURE NO. 6665

ISLAND LAKE

JOB NO. 5221 (CEI 4)

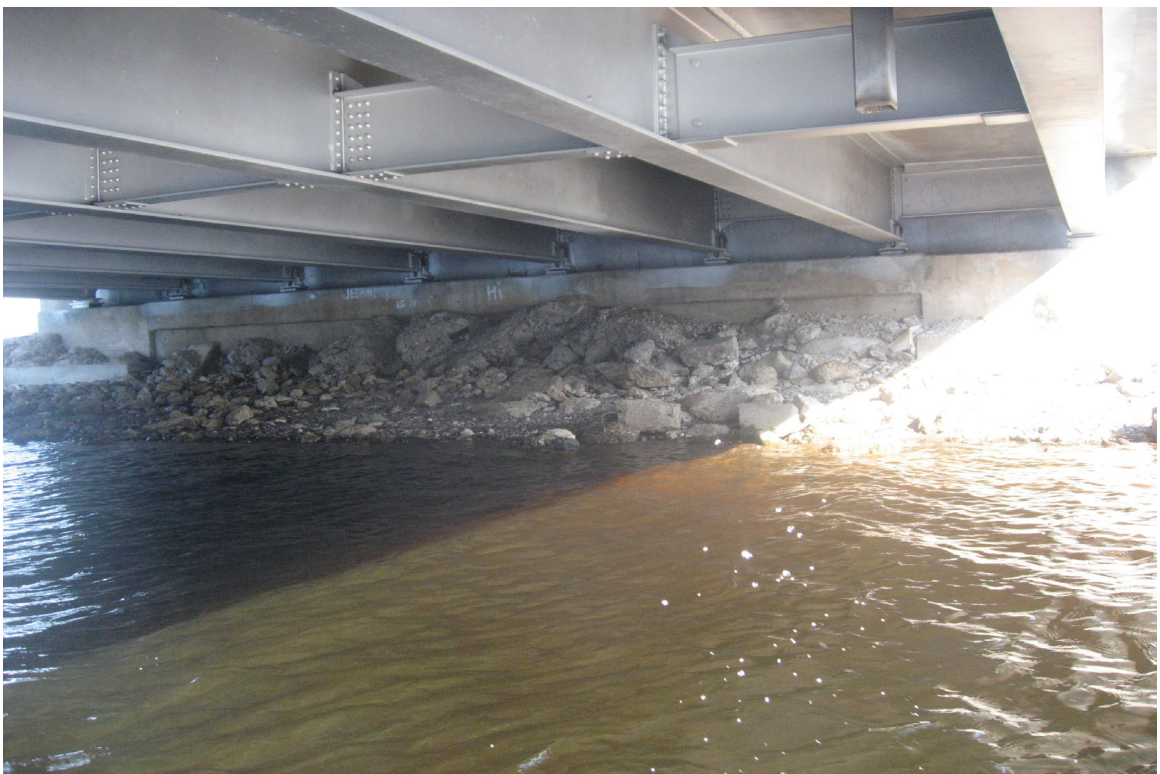
Photograph 2. View of North Abutment, Looking North.

- 8 Footing exposure was observed at west and east ends of north and south abutments with a maximum vertical exposure of up to 2 feet.

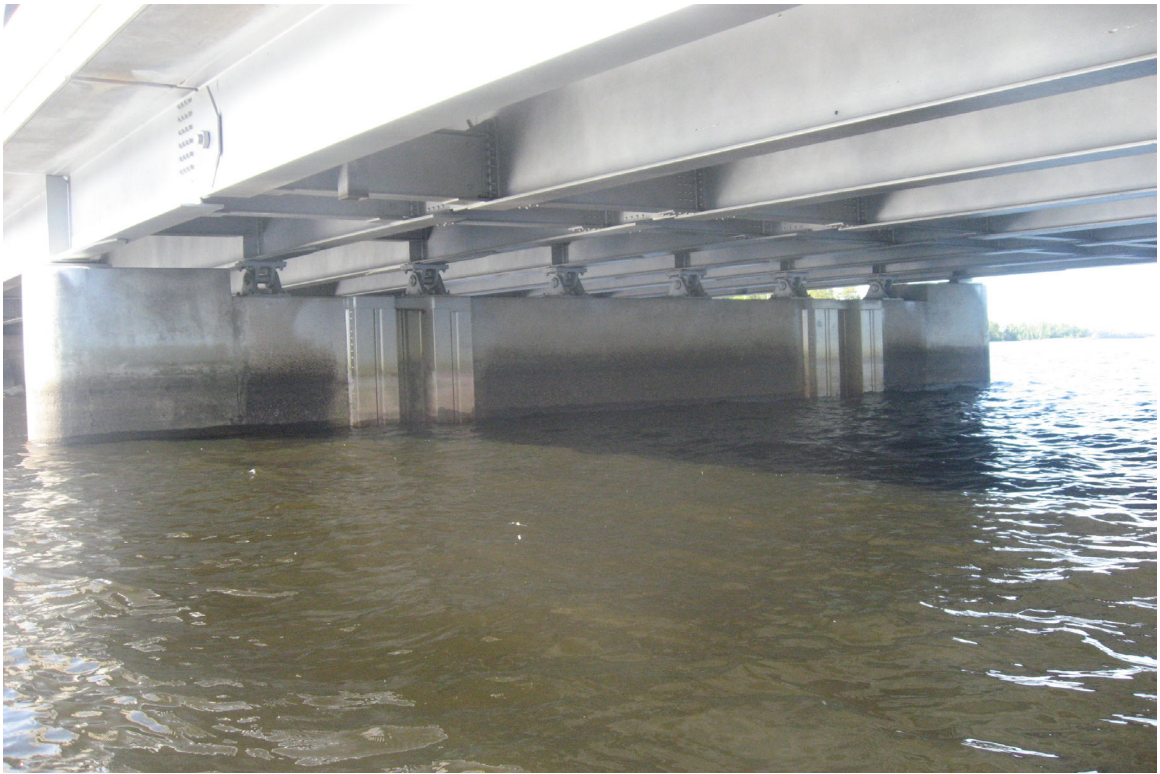
Photograph 3. View of Pier 1, Looking Southwest.

- 3 Moderate scaling with typical penetrations of 1/4 inch and up to 1/2 inch maximum penetration with exposed aggregate on the older concrete surfaces in the middle of Pier 1, extending from approximately 3 feet above the waterline to 2 feet below the waterline.

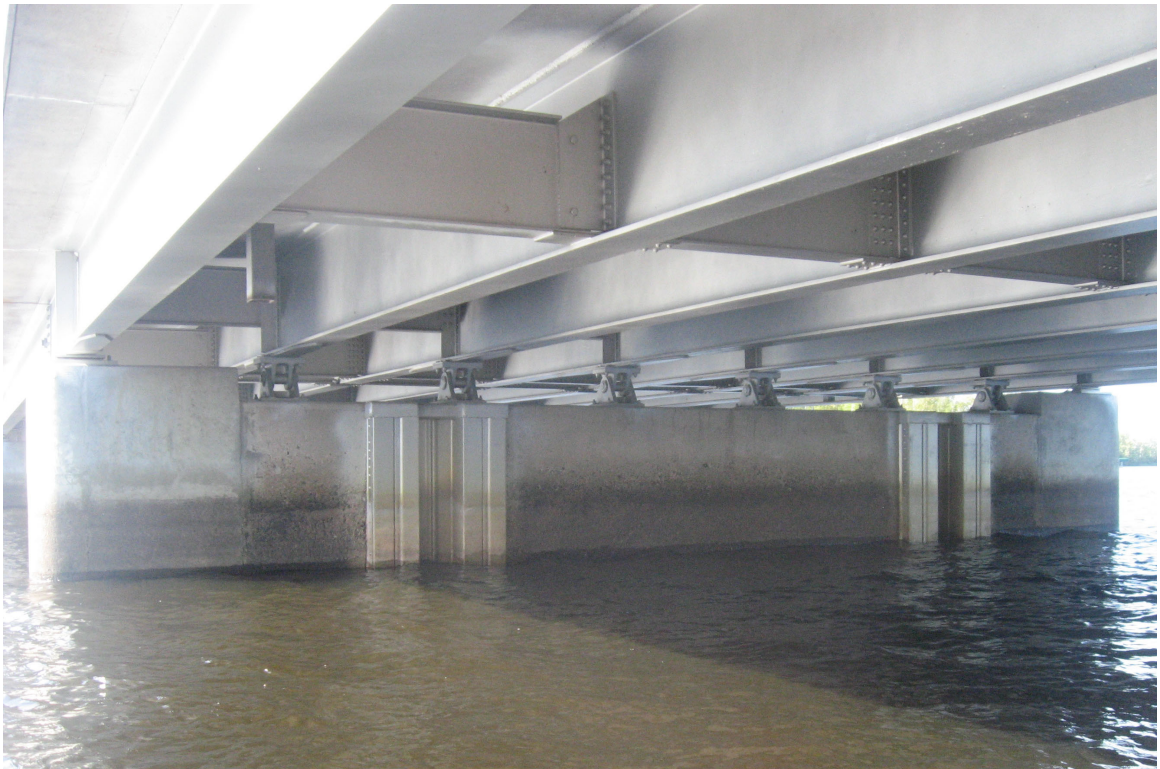
Photograph 4. View of Pier 2, Looking Southwest.

- 2 Moderate scaling with typical penetrations of 1/4 inch and up to 1 inch maximum penetration with exposed aggregate on the older concrete surfaces in the middle of Pier 2, extending from approximately 3 feet above the waterline to 2 feet below the waterline.

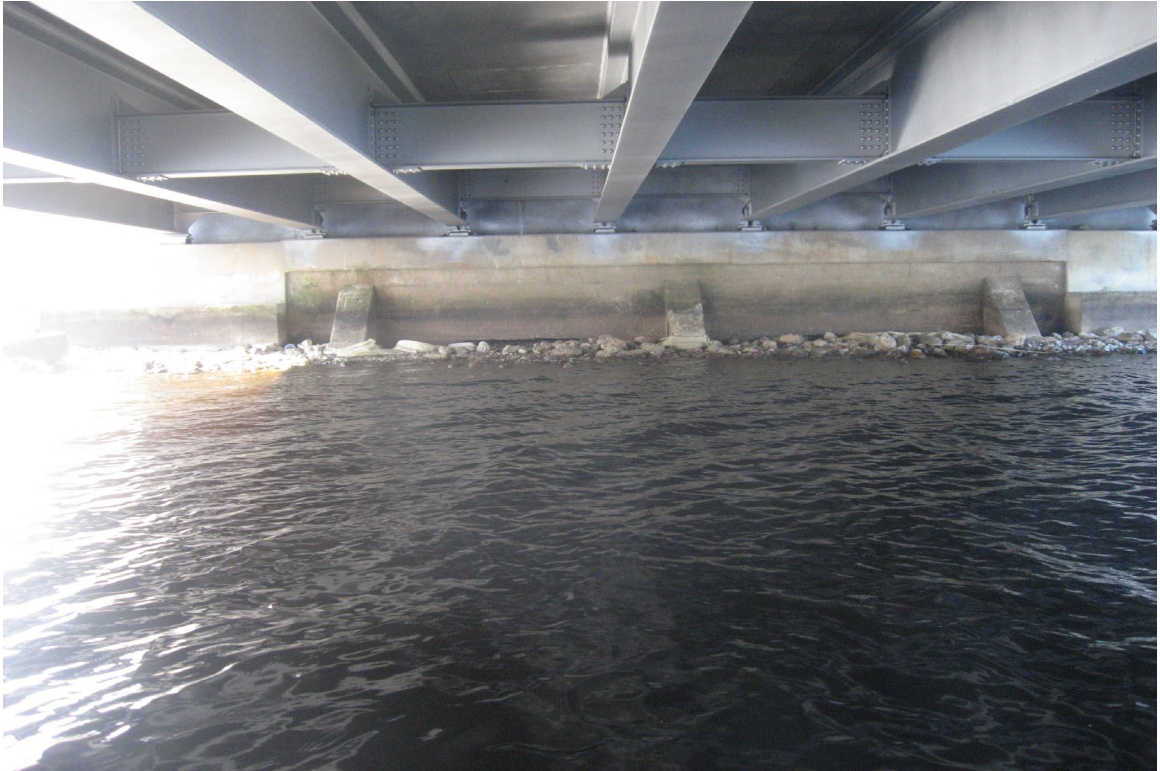
Photograph 5. View of South Abutment, Looking South.

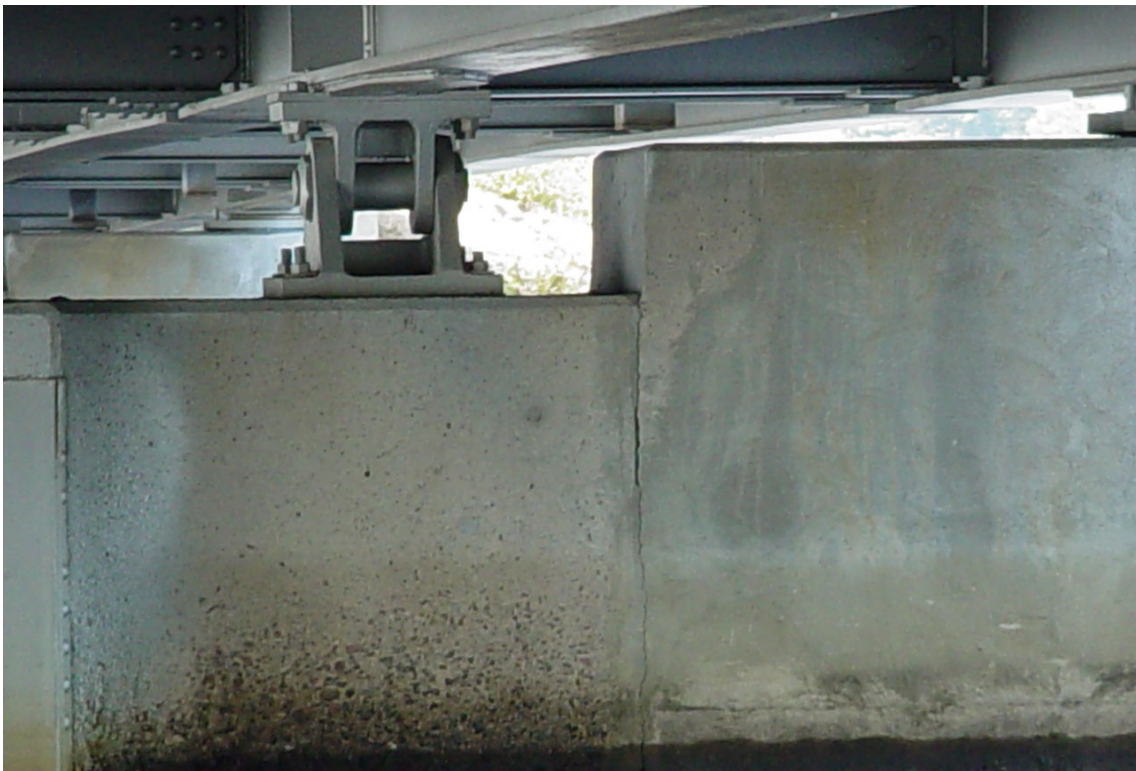
- (E) Vertical cracks were observed in the joint between the newer end concrete and the original middle section concrete of the piers, with maximum widths of 1/8 to 1/2 inch.
- (F) Footing exposure was observed at the west and east ends of North and South Abutments with a maximum vertical exposure of up to 2 feet.

Photograph 6. View of typical cracking on Pier 1 (between original and addition concrete), Looking Northwest.

- 4 Cracking between new and old concrete along entire interface, typically hairline to 1/8 inch wide with 1/2 inch maximum width (at south side of Pier 2).

- (A) Monitor cracking between the original and new concrete of piers, and if found to be worsening, repairs with epoxy based materials may be required. The cracking appears stable (same as last inspection, no differential movement), but could be aggravated by freeze/thaw action, and should therefore be monitored during future inspections.
- (B) Reinspect the submerged substructure units at the normal maximum recommended (NBIS) interval of five (5) years.

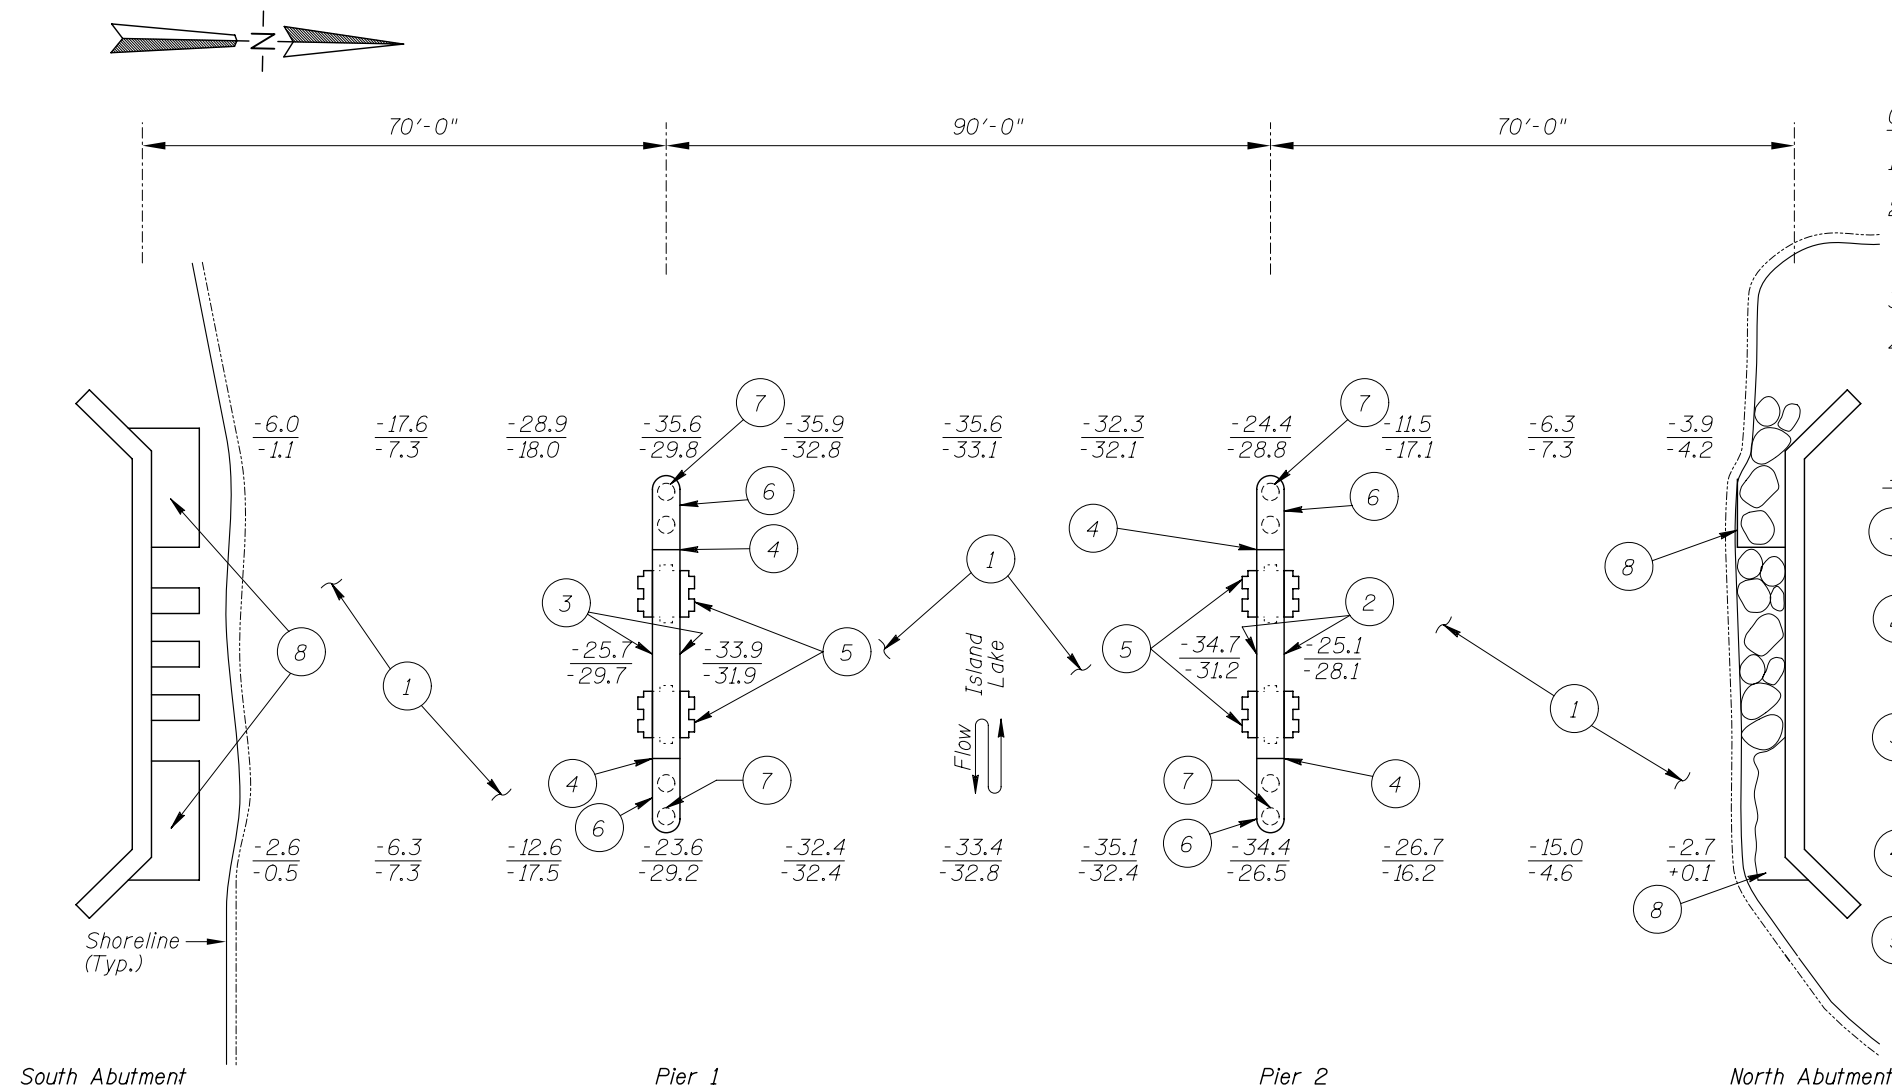
INSPECTION AND SOUNDING PLAN

- 1 The channel bottom consisted of sandy gravel with widespread 6 inch to 1 foot diameter riprap, overlaid with up to 1 inch of soft silt, allowing 1 to 2 inches of probe rod penetration.

- 5 Rust nodules and surface corrosion were observed on all of the steel columns along the entire length, with the heaviest concentration (up to 1.5 inch diameter and/or uniform coverage) exhibited on the lower half, with 75 to 100 percent of the surface area covered and section losses up to 1/16 inch deep. On the upper half, lesser concentrations of up to 1 inch diameter nodules, with up to 50 percent of the surface area covered and section losses up to 1/8 inch deep.

- 6 Light scaling with 1/4 inch of maximum penetration on the newer concrete surfaces at the ends of Piers 1 and 2 in a 1.5 foot band at the waterline.

- 7 Steel shell piles under pier widening additions exhibited surface corrosion ranging in coverage from 25 to 50 percent on upper 20 to 25 feet, and 80 to 100 percent with rust nodules on the bottommost 6 to 10 feet. Nodules typically have up to 1/32 inch deep pitting and a maximum of 1/16 inch deep pitting on the upper 10 feet of the piles.
